**CONSTRUCTION REPORT FOR THE
PERMEABLE REACTIVE BARRIER
GROUNDWATER INTERIM MEASURE
GRENADA, MISSISSIPPI**

**ArvinMeritor
Troy, Michigan**

April 2006

**Brown and Caldwell
501 Great Circle Rd, Suite 150
Nashville, Tennessee 37228**

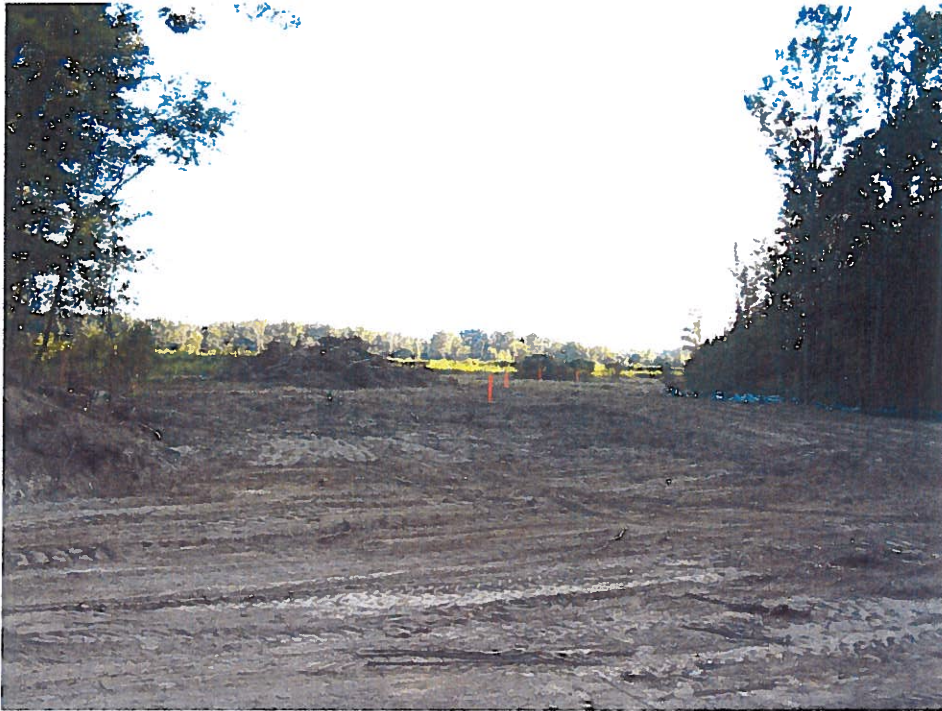
1. 9/14/05: Area cleared. PRB centerline staked out Looking south.

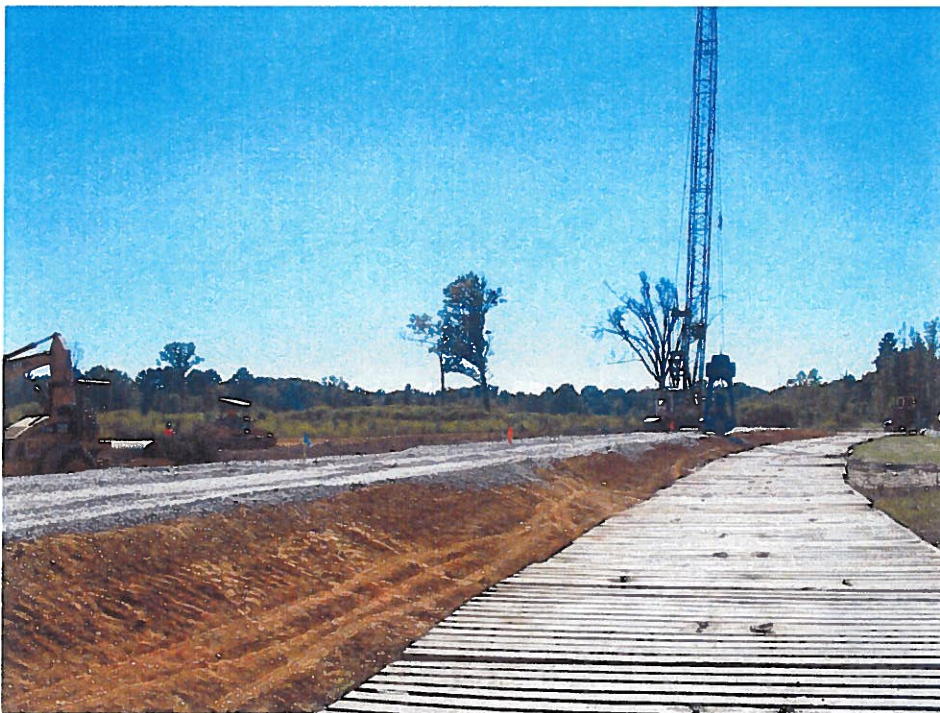
2. 9/30/05: Work platform and construction access road (or mat road). Looking south.

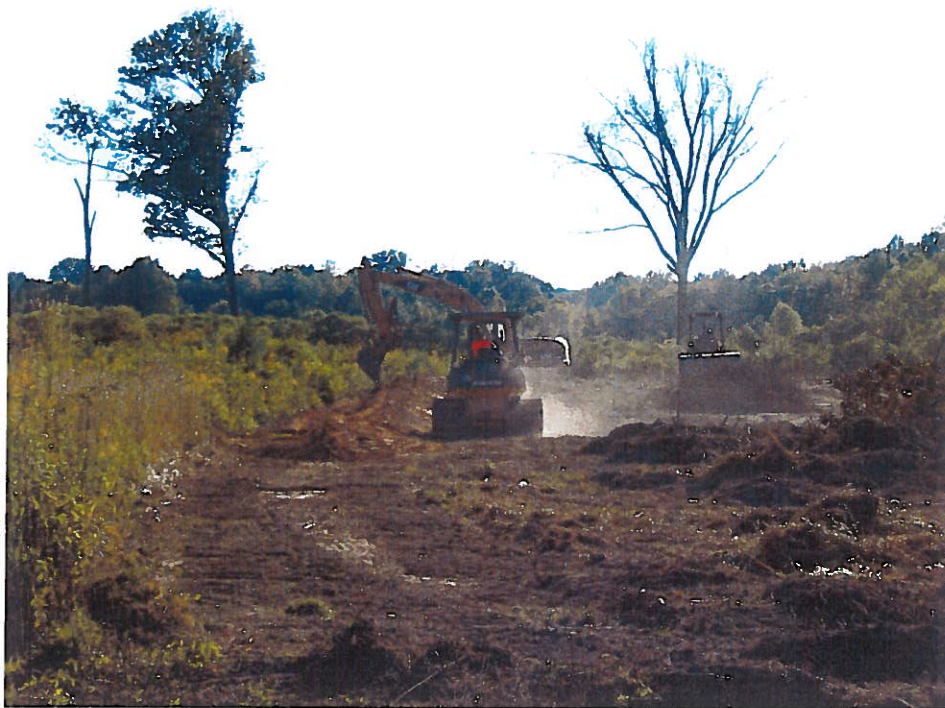
3. 9/30/05: Spoils berm construction. Looking south.

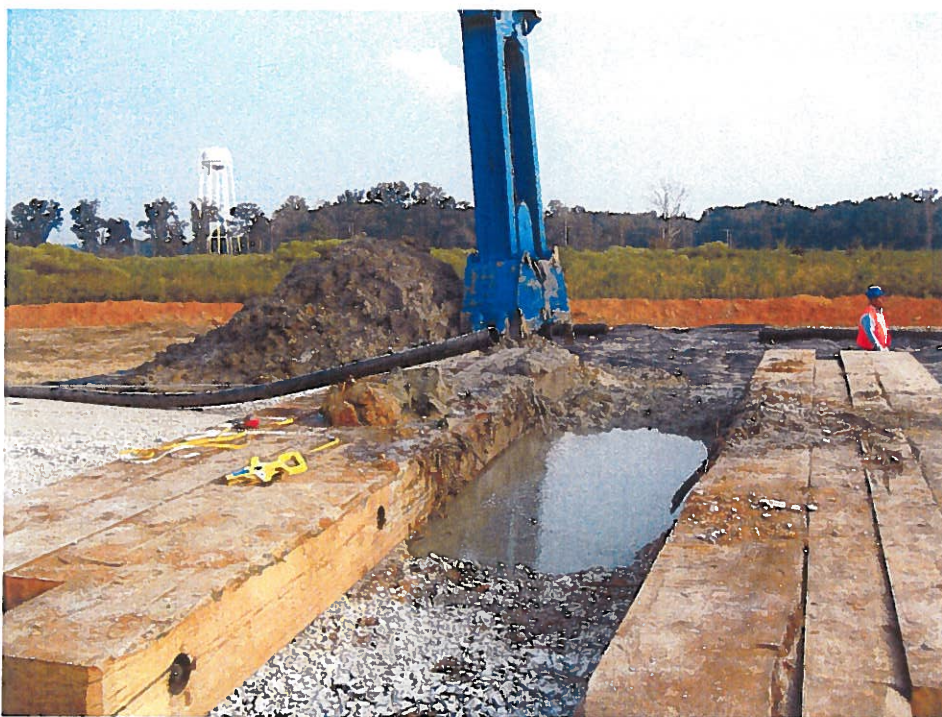
4. 10/01/04: Trench excavation for concrete end-stop construction using Supermud-biopolymer slurry. Excavated material is placed over geotextile fabric in spoils area. Looking east.

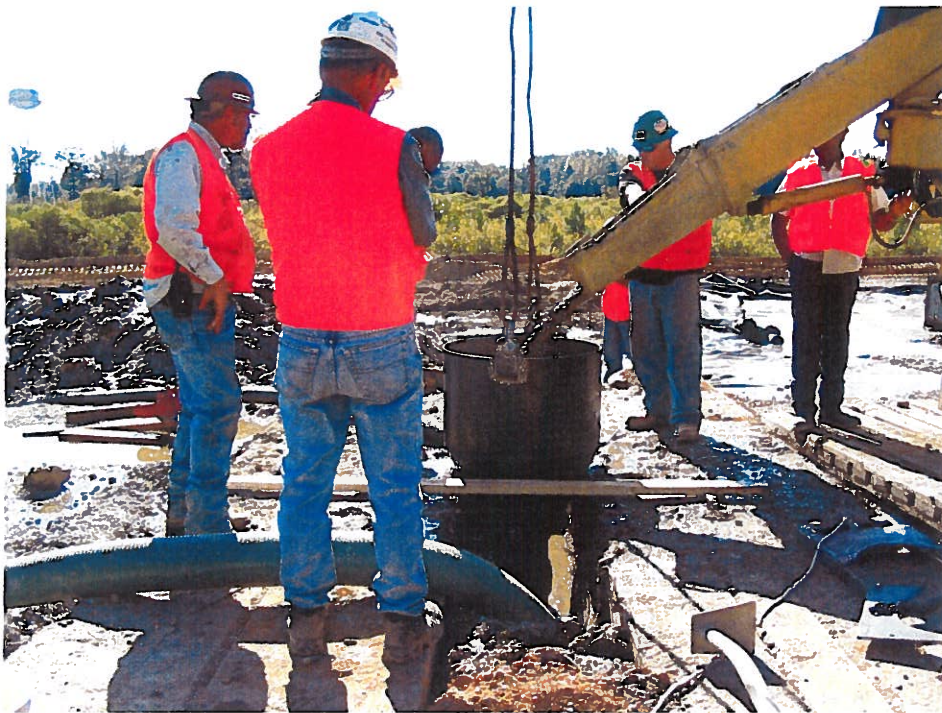
5. 10/6/05: Pouring concrete for end-stop construction. Looking east.

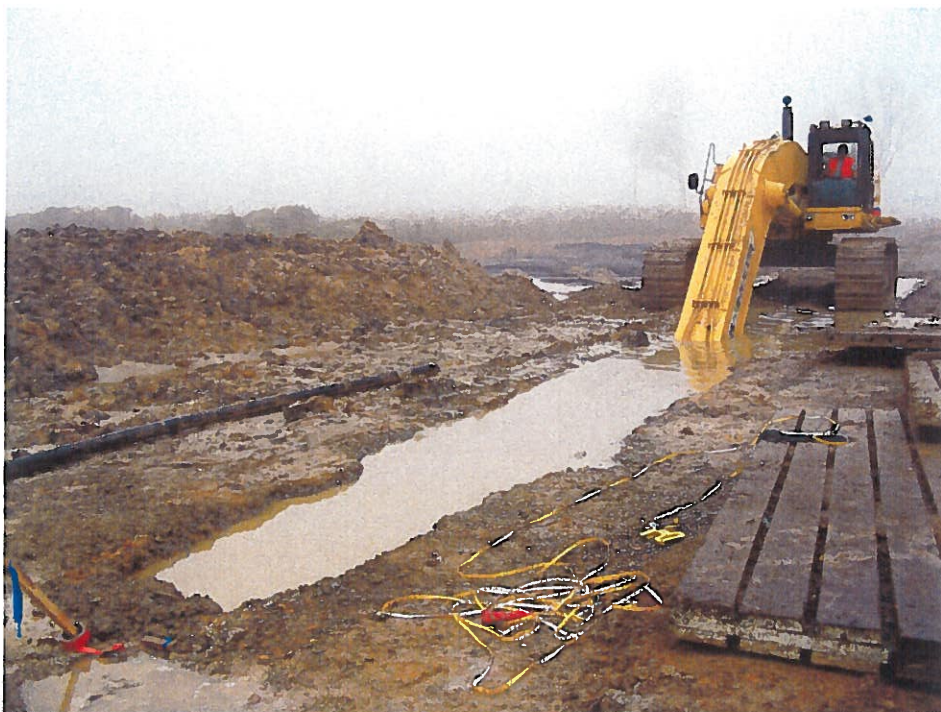
6. 10/20/05: Trench excavation for PRB construction using biopolymer slurry. Looking south.

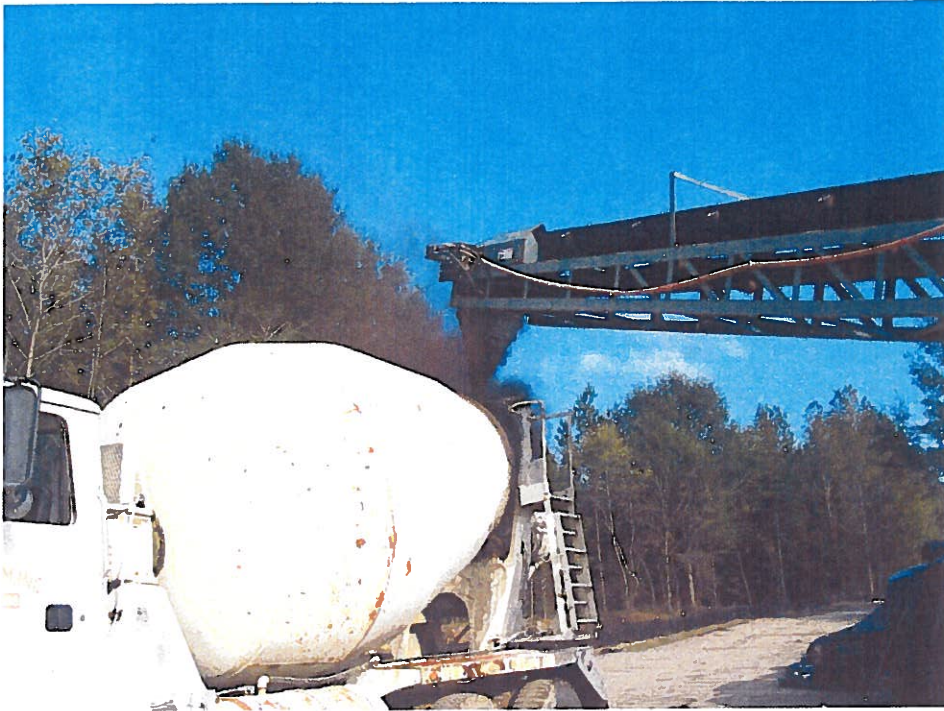
7. 10/20/05: Filling iron and sand into concrete truck using conveyor.

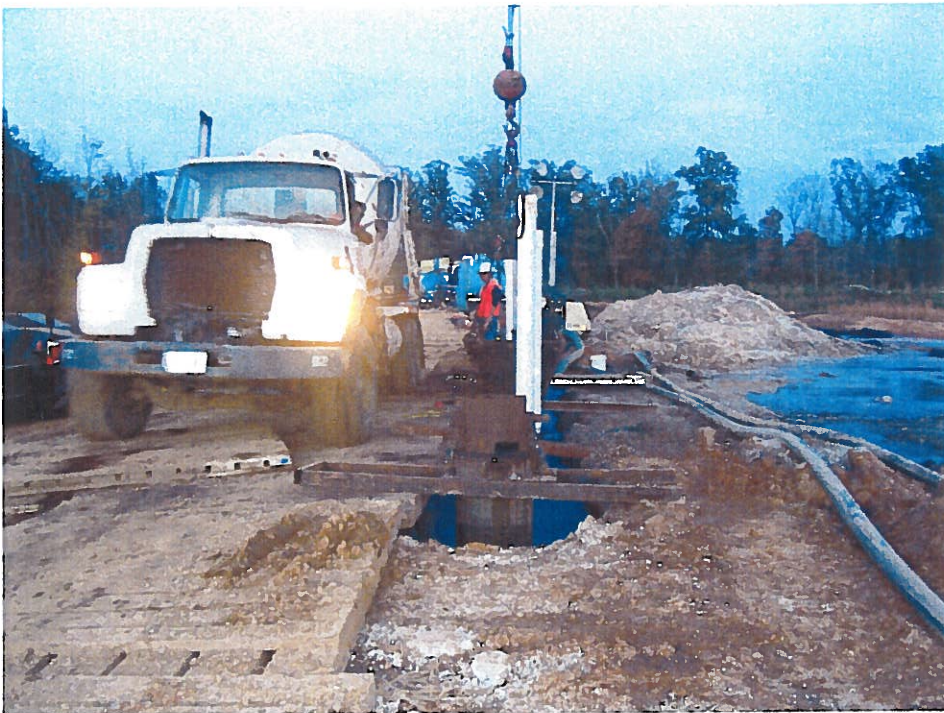
8. 10/26/05: Backfill trench with iron-sand. Looking north.

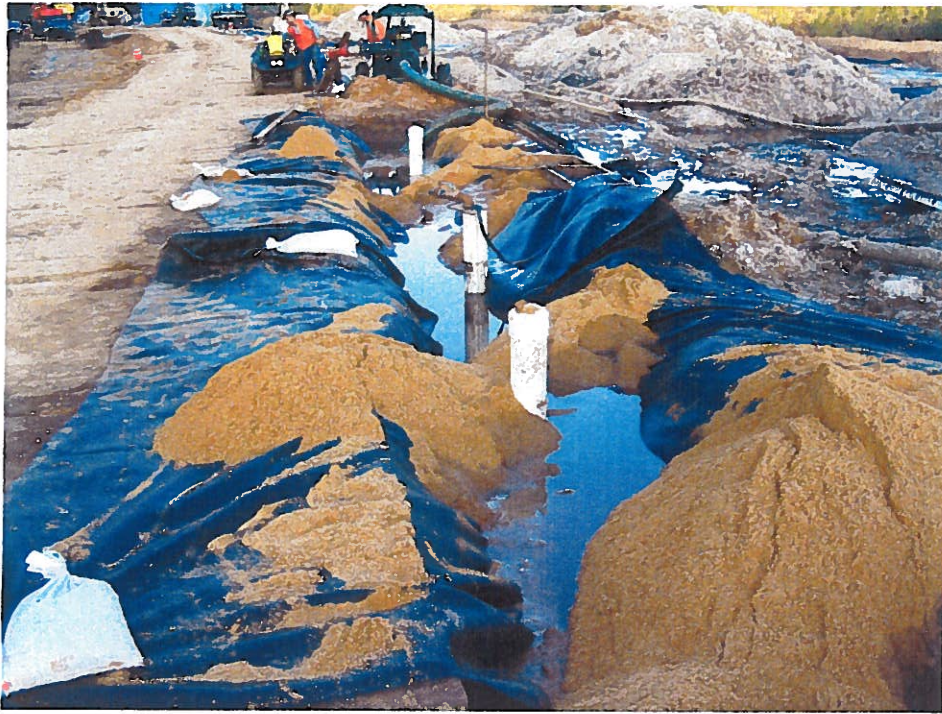
9. 10/29/05: Capping PRB trench with geotextile and sand. Looking north.

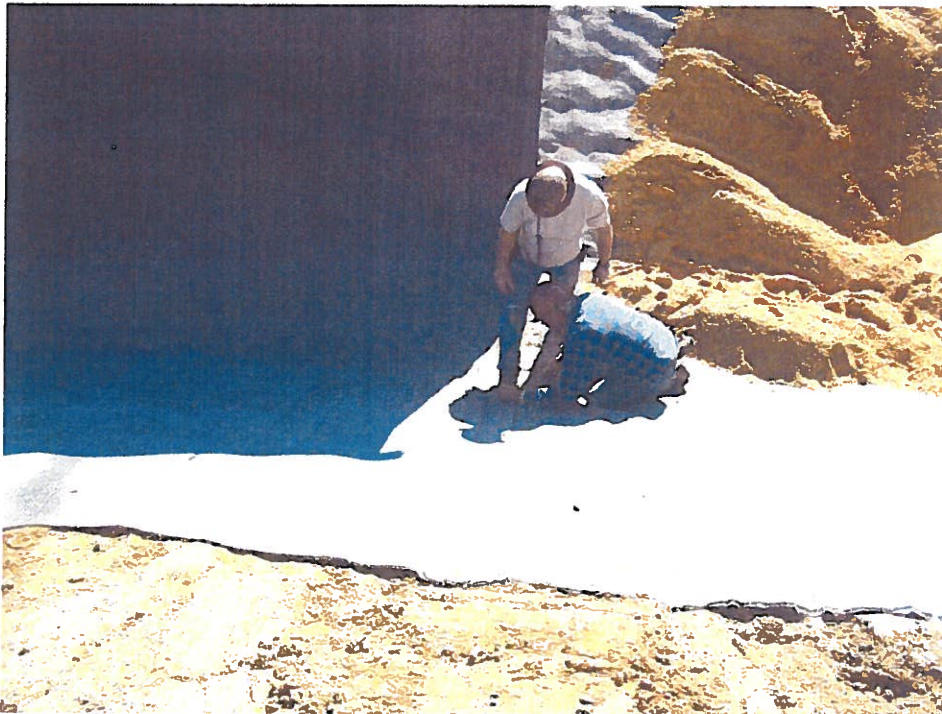
10. 02/04/05: Placing GCL and cover soil across PRB in outfall ditch.

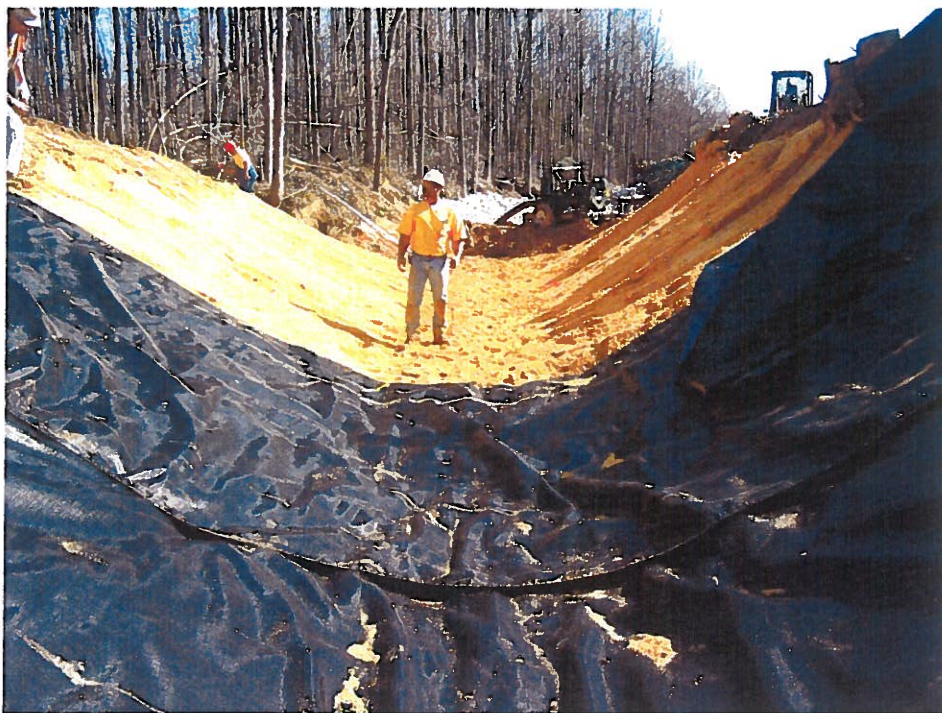
11. 02/05/05: Placing geotextile fabric over cover soil. Looking east.

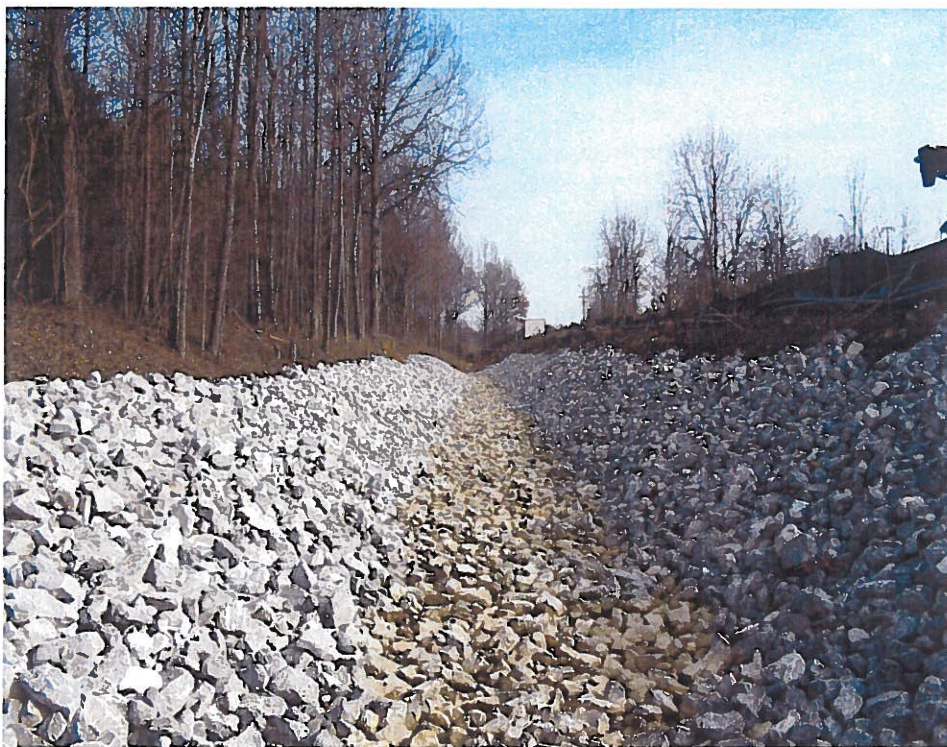
12. 02/05/05: Riprap placed over geotextile in outfall ditch. Looking east.

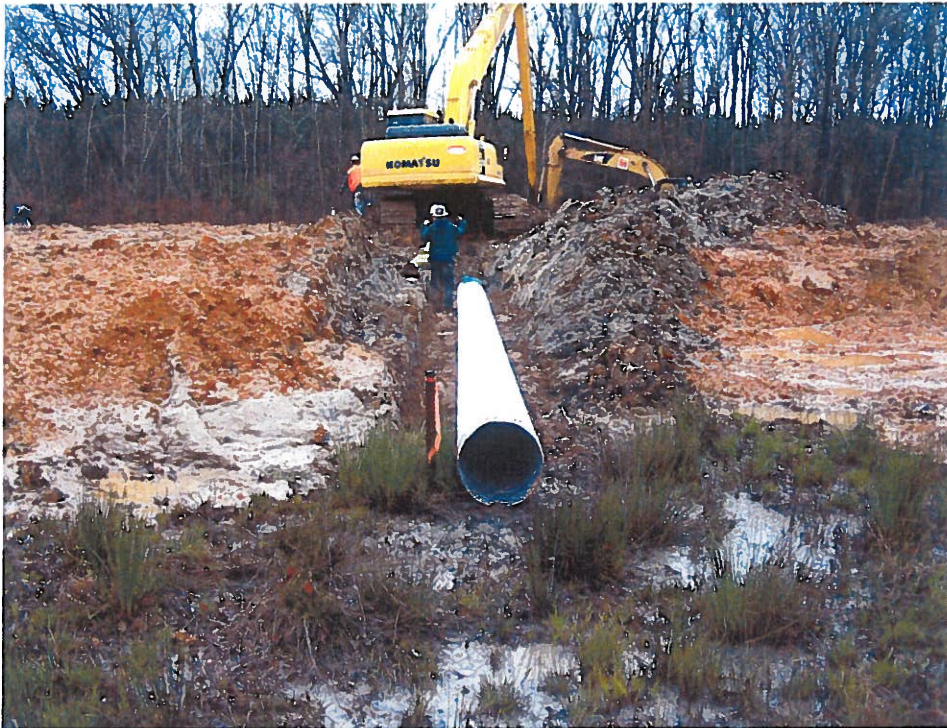
13. 03/09/05: Installing 18" culvert across PRB. Looking west.

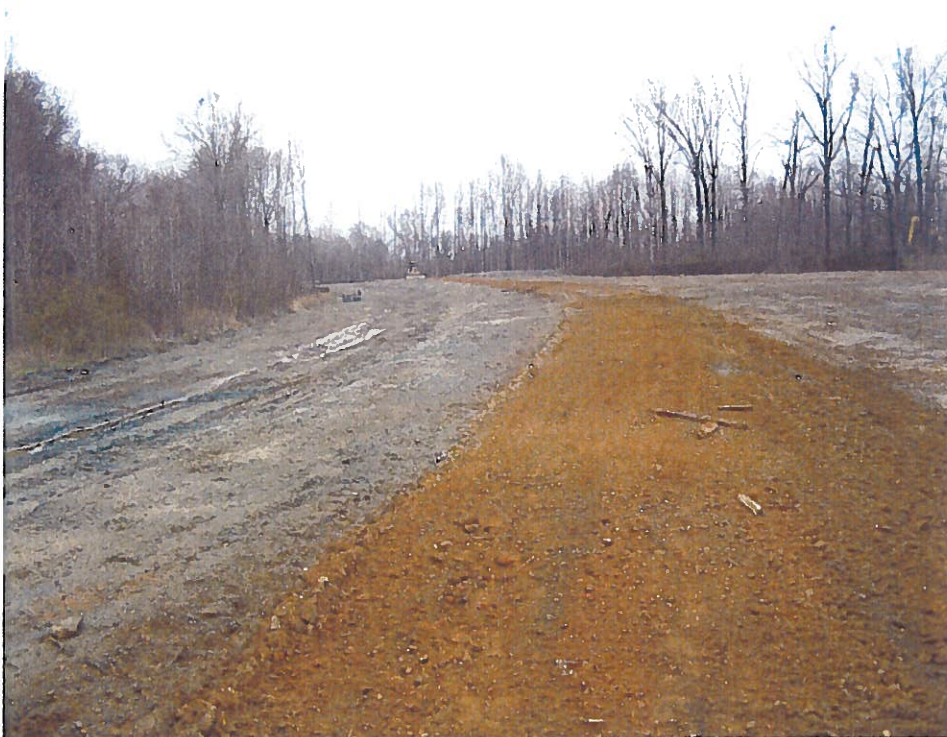
14. 03/16/05: Spoils and restored areas seeded. Access road on PRB centerline. Looking north.
